## CASE STUDY

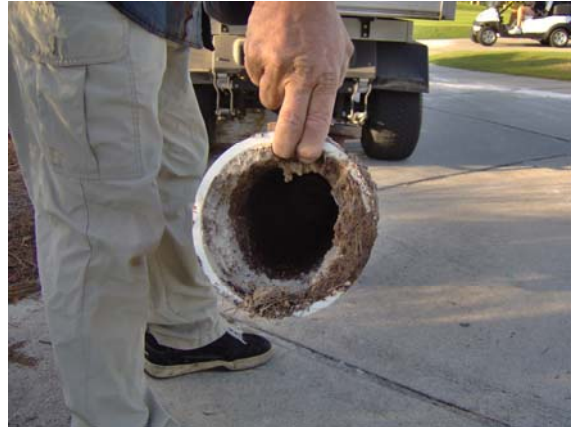
### BACKGROUND

*Cross sectional view of build up inside pipe*

The build up was analyzed and it was determined that the deposits were predominantly Calcium based. Water conditioners have been used successfully in the residential market for decades for calcium. A trial was set up to treat approximately 3 holes of the golf course with a water conditioner. Evaluations would be made on this section of pipe to determine if the treatment was successful.

### RESULTS
